CASE STUDY/wastewater treatment plant

HARRISON COUNTY, MISSISSIPPI

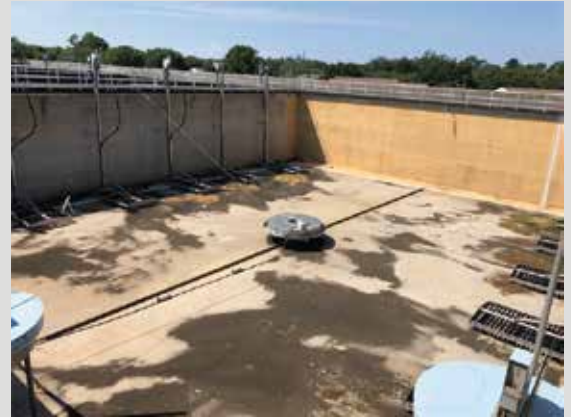
The original construction of the water treatment tanks included two main vertical joints with a water stop set between the concrete joints. The floor of the tanks is built, by design, where water migrates under portions of the floor to create a floating effect. Facility managers noticed water leaking from both vertical joints as well as seepage through parts of the walls, so exploratory measures were taken.

Initial repairs included a waterproof coating sprayed on the walls and across the joints as well as a strip of waterproofing material installed over all joints in the interior of the structure. Wall seepage stopped meaning the coating did the trick, but the vertical joint leaks persisted.

Helms Polyfoam was brought in to trace and seal off the leak using a unique polyurethane resin designed specifically for this type of application. Investigation found the leak was actually coming from beneath the floor, completely bypassing the topical joint seal. Once the penetration point was found, a low viscosity, hydrophobic resin was injected with a slow catalyzation. The hydrophobic properties are designed to repel and “chase” water while the low viscosity component made sure that anywhere water could get, so could the resin. Lastly, the low catalyzation ensured that the resins ran the entire water path prior to curing.

One other important point about the polyurethane resin used; hydrophobic and polyurethane resins typically means a semi rigid foam is produced. In this instance though, the resin used possess a fairly high tensile elongation percentage, which will allow it to flex in the joint with the seasonal concrete movement. This very important detail prolongs the success of the repair and could not be achieved with “normal” hydrophobic polyurethane resins.
