## CASE STUDY/RIVERWALK CASINO

1046 Warrenton Rd, Vicksburg, MS 39180

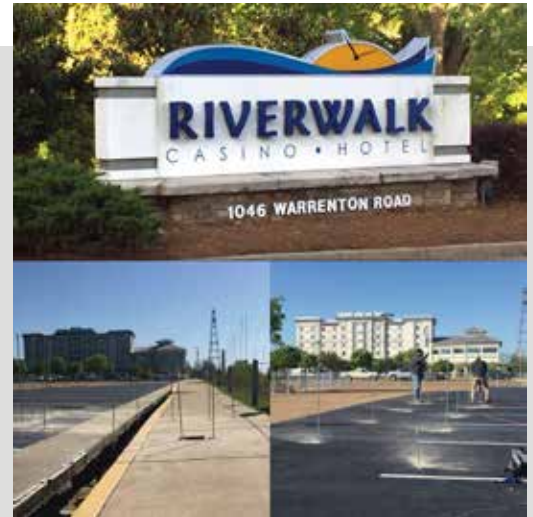
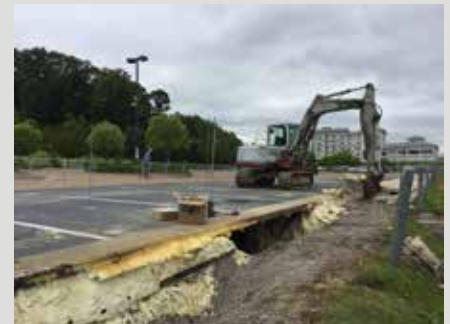
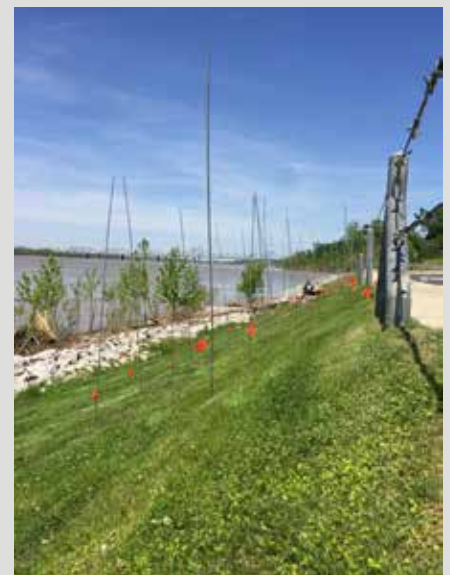
The casino property has a large parking lot and sidewalk adjacent to the river. Over time, the soil under the parking lot grew weak due to poor compaction and water erosion. This caused the concrete structures atop the soil to sink. The sinking concrete put strains on the property drainage system, that ultimately resulted in a pipe joint failure. This pipe failure caused the flowing drain water to rush freely under the parking lot. The water then forced its way into a concrete basin where it began pulling away soil and rocks from the Mississippi River Bank, creating a large void, and causing the river bank to collapse. After two failed repair attempts, utilizing a full demolition and replacement of soil and concrete, Churchill Downs and Riverwalk Casino decided it was time to fix the problem permanently. They called the soil stabilization professionals at Helms Polyfoam.

Helms Polyfoam, along with a forensic engineering firm, conducted a thorough site evaluation to determine not only how to fix the current problem, but how to stop it from recurring. First, the main void was filled with AP 475 to create a strong foundation for heavy equipment to work. Second, all concrete structures were stabilized by utilizing deep injection methods at pre-determined points surrounding problem areas. Next, we performed a multilayer soil squeeze in a grid pattern, spanning 110' of the Mississippi River bank. This soil squeeze compacted all weak soils that collapsed as well as created a water impermeable barrier along the bank. After this, we performed the exact same method on the opposite side of the void to ensure stabilization of soils throughout the entire problem area. We monitored the entire process with zip levels and rotating laser levels. Once we reached positive pressures, the structures as well as the levee began to rise to an even height, giving us confirmation that the soil was stabilized. With the void filled and the soil stabilized, the parking lot was ready for new sidewalks and a fresh layer of landscape to further prevent erosion.
